# Joint Network Secretariat Urgent Procedure Task Force Broken wheels

# Agreement of the TF on short term mitigation measures

28<sup>th</sup> July 2017

# Task Force Broken wheels – Proposal Short Term measures Summary

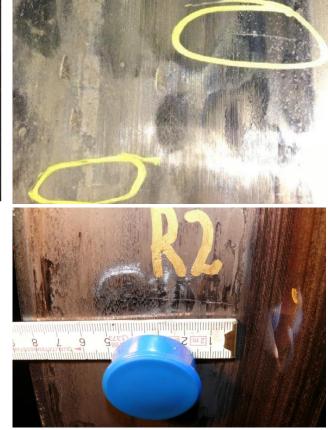
**Description:** The tread exhibits cracks at an angle of approximately 90° to the circumference of the wheel and have a typical length of 30mm or more. Transverse cracks generally develop at the surface in either straight or slightly crooked lines and can penetrate radially (usually of thermal origin in these cases) or branch out in a circumferential direction (usually of mechanical origin in this case). They occur individually and can be distributed at several points around the circumference. [EN 15313, §C.2.6]

Transverse crack revealed by magnetic particle testing [EN 15313, §C.2.6]

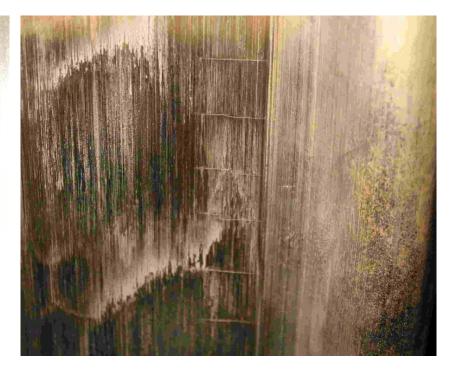
Example for single cracks on the wheel tread by visual inspection

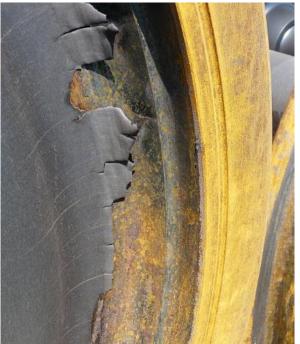
**Description:** This type of defect occurs only in tread-braked wheels. When suitable coatings are used, the paint becomes clearly burnt in the rib/web transition radius when the temperature exceeds approximately 300 °C. The paint in this area then becomes cracked and peeling. The brake blocks are often melted to some extent. Build-up of metal and characteristic colouring can be seen on the tread. The rim may also become a bluish colour.

Old and fresh burnt paint

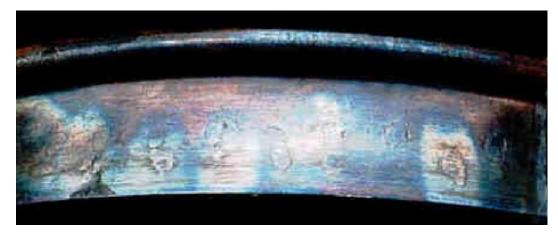
colouring on the tread

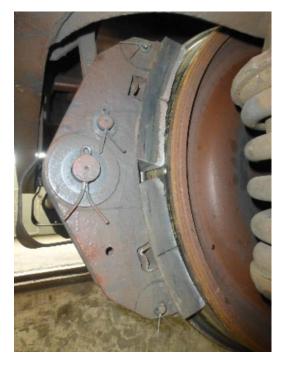
Melted brake block
